REPORT ON FLOODING AND FLOOD RELATED DAMAGES IN SANTA CLARA COUNTY

FEBRUARY 12 TO 20, 1986

Joan A. Maher
Associate Civil Engineer
Technical Services Division

JUNE 1988

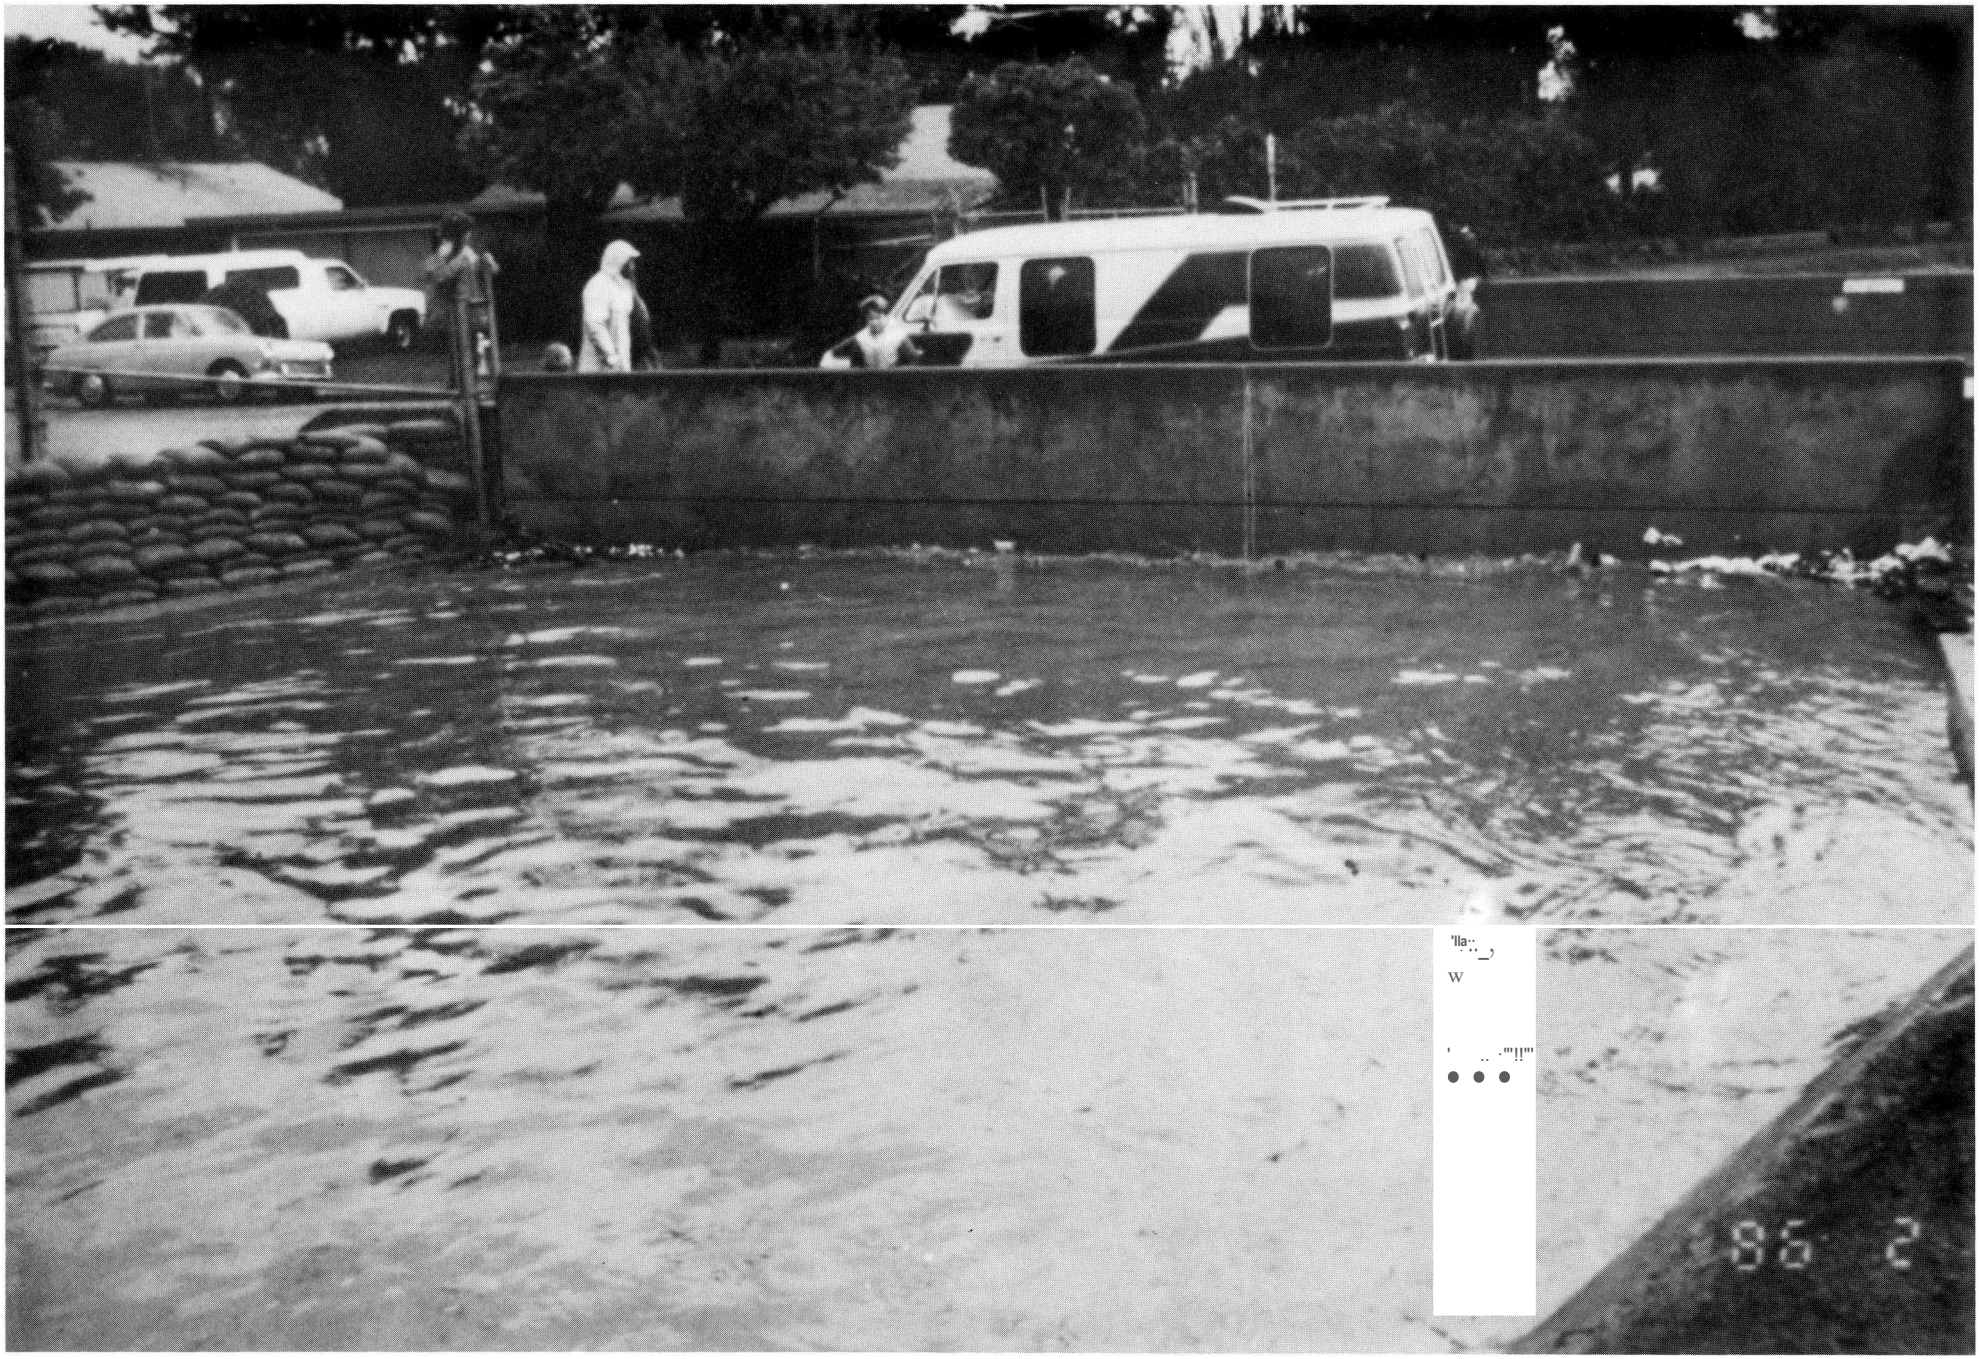
MATADERO CREEK AT GREER **AVE. 2/ 14/86**

CALABAZAS CREEK AT MILLER AVE. 2/ 14/86

FLOODING FROM UVAS-CARNADERO CREEK NEAR THOMAS ROAD, GILROY 2/ 18/86

BUILDING TEMPORARY LEVEE ON UVAS-CARNADERO CREEK NEAR THOMAS ROAD, GILROY 2/18/86

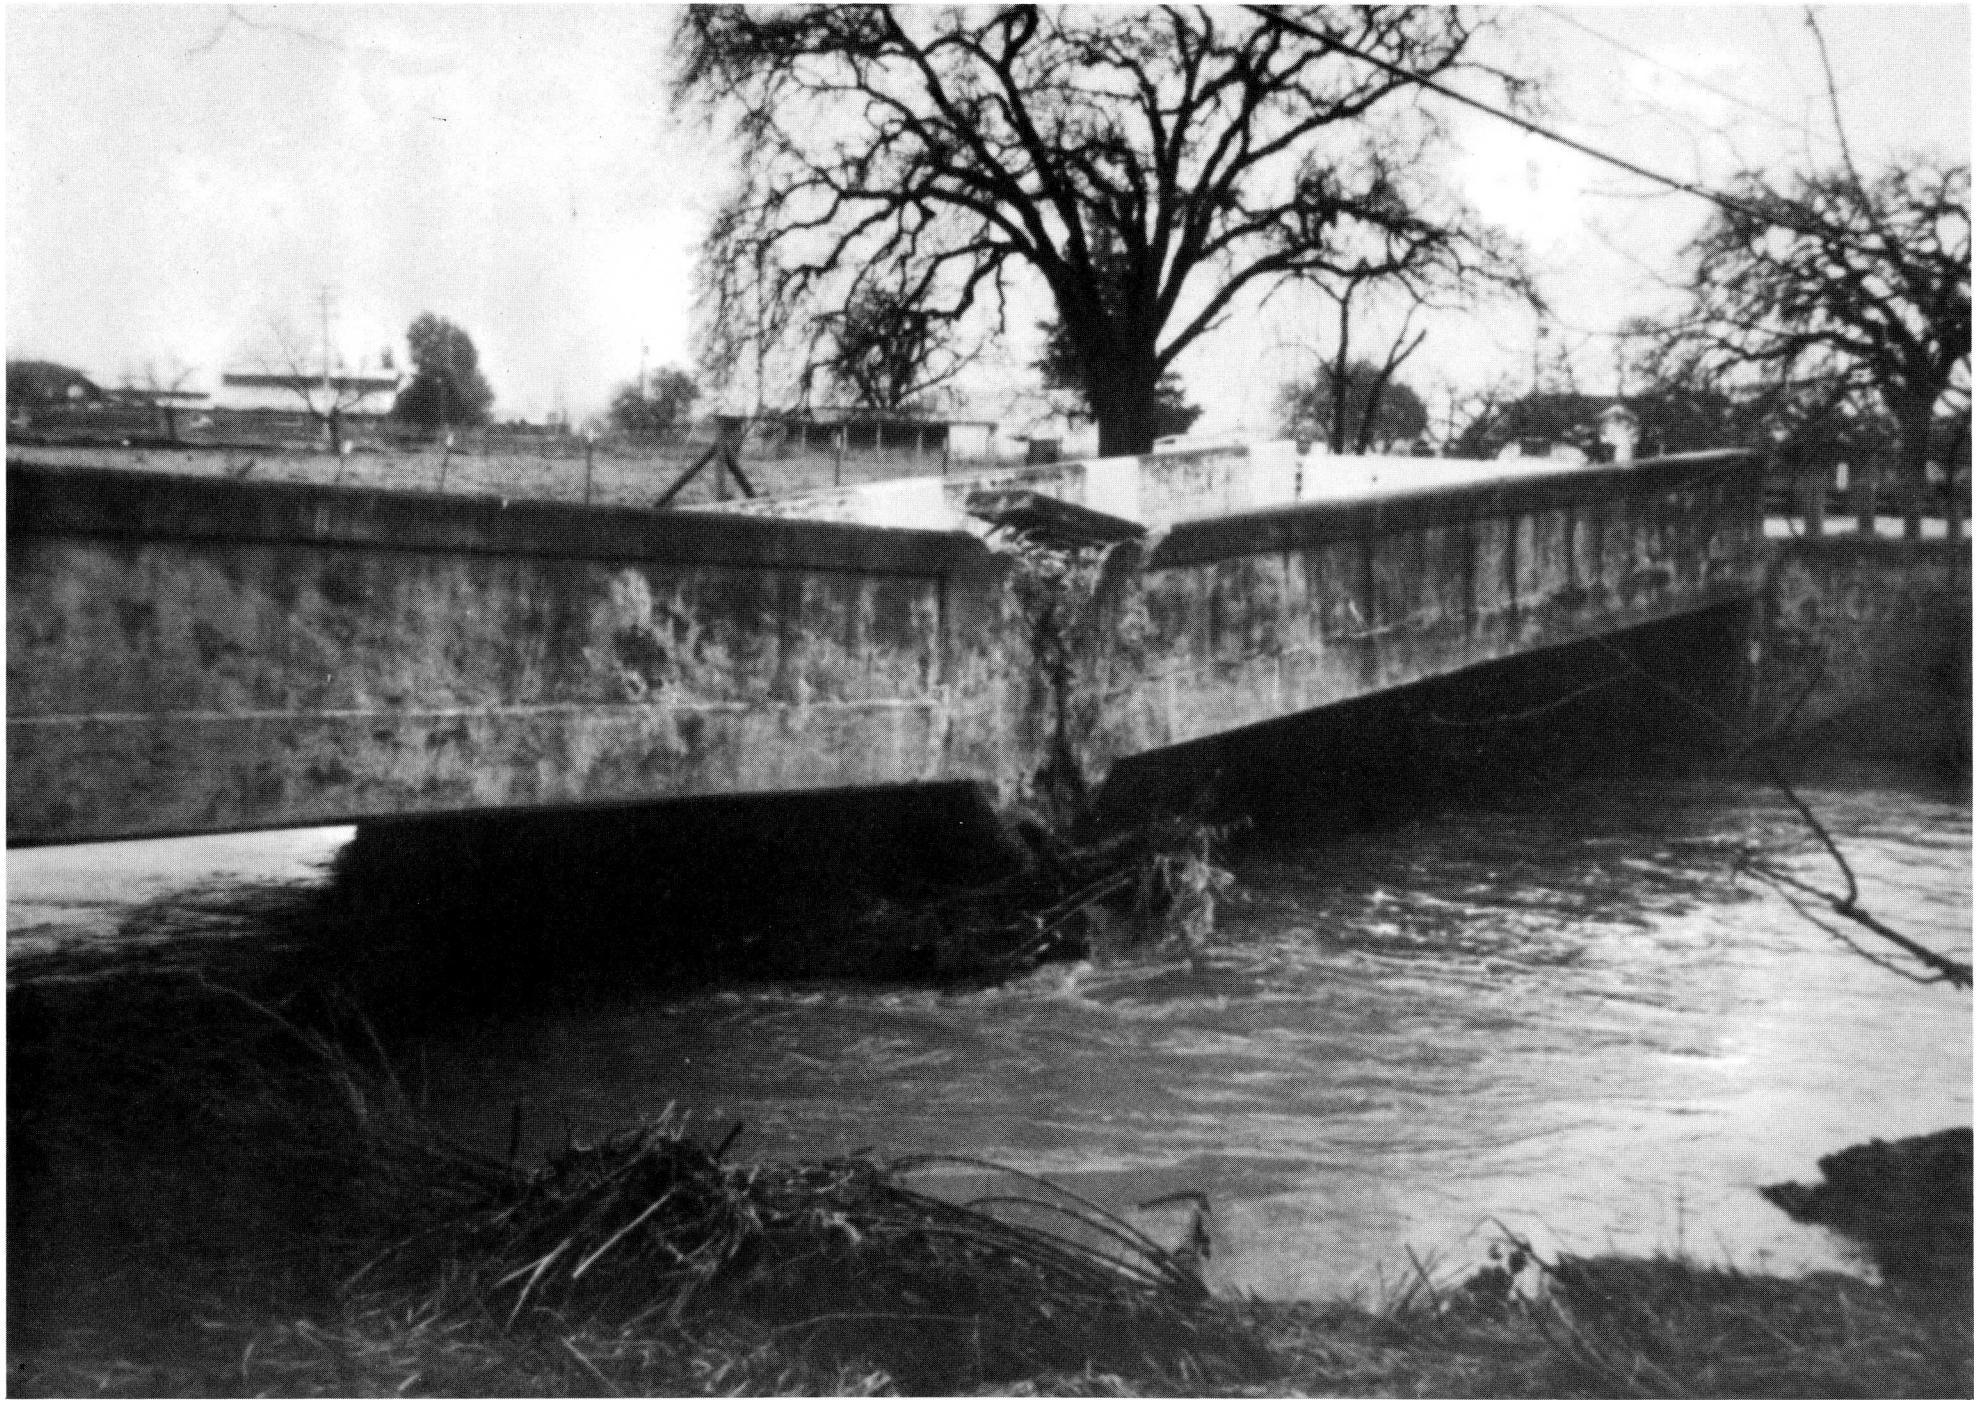
4) Engineers fran the Corp of EngineE.:rs and State OES are reviewing the situation at Rucker Avenue in which Santa Clara Collllty is requesting the ranoval of the bridge over Llagas Creek due to its perilous condition. A favorable decision is expected in which case we will ask the Corp of Engineers to derolish the bridge. Its continued existence in its present condition could eventually cause flooding of nearby hanes.

LLAGAS CREEK AT RUCKER AVE. BRIDGE FAILURE 2/ 19/86
